# KINGSTON PUBLIC HOSPITAL

Structural Survey on Mary Seacole Ward

02/08/2018

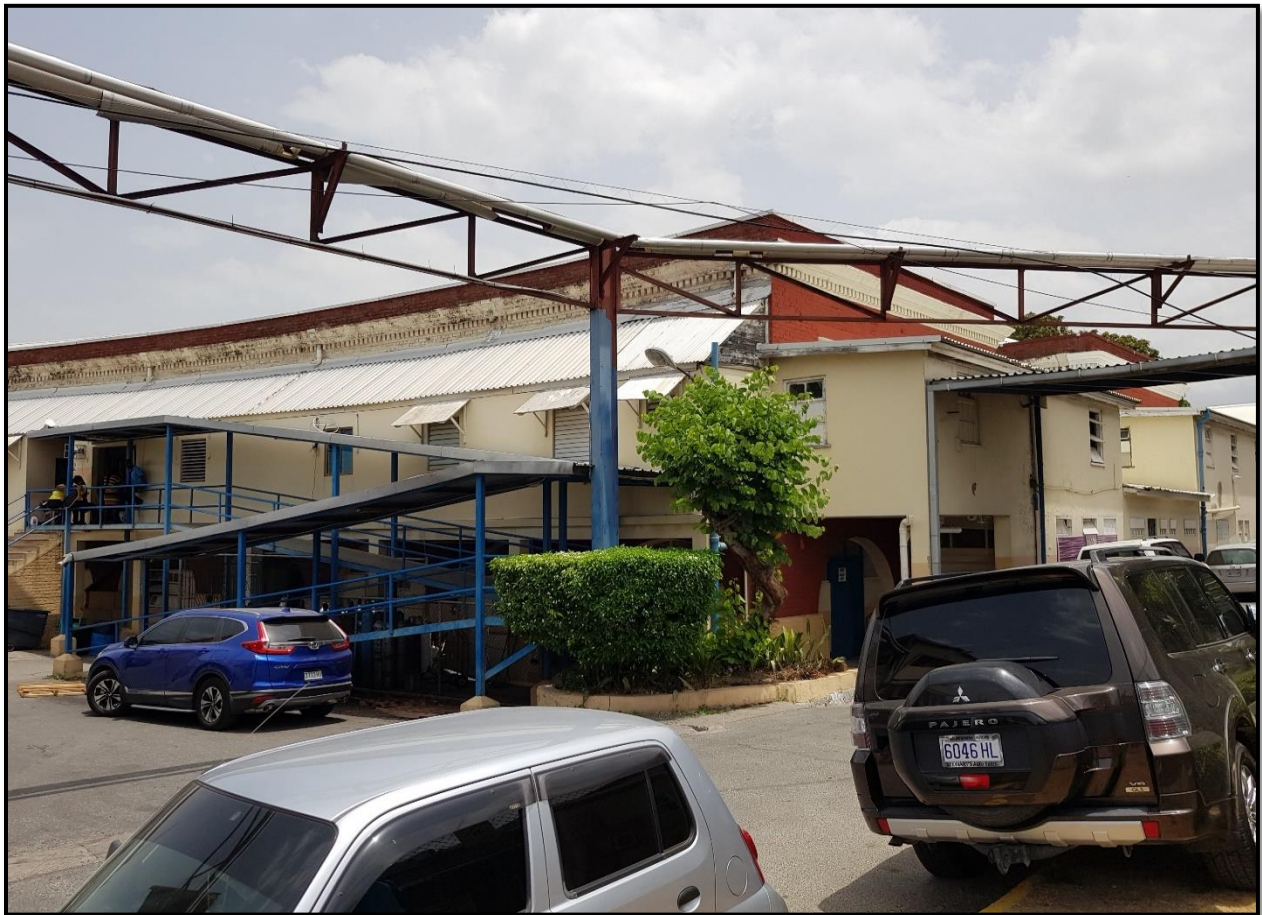
The building is a two story structure; Mary Seacole Ward is on the ground floor. The building has flat roof which slopes (less than 10 degrees) for water drainage as seen in figure 1 below. The roof spans 114 feet by 51 feet. The roof is made from timber beam and trusses to support the Roof loads. The first floor was also made from timber beams and trusses and is seen to be in a poor condition.

Figure 1. Showing the angled roof

- Repair and replace all faulty material that facilitate leakage
- Ensure that no other additional load is added to the structure (due to its age and the current failures observed)
- Clean and repair roof then add a waterproofing membrane to prevent further leakage
- Redo all defective concrete masonry works
- Conduct regular maintenance checks
- Inspect, clean and seal cracks for the drainage system

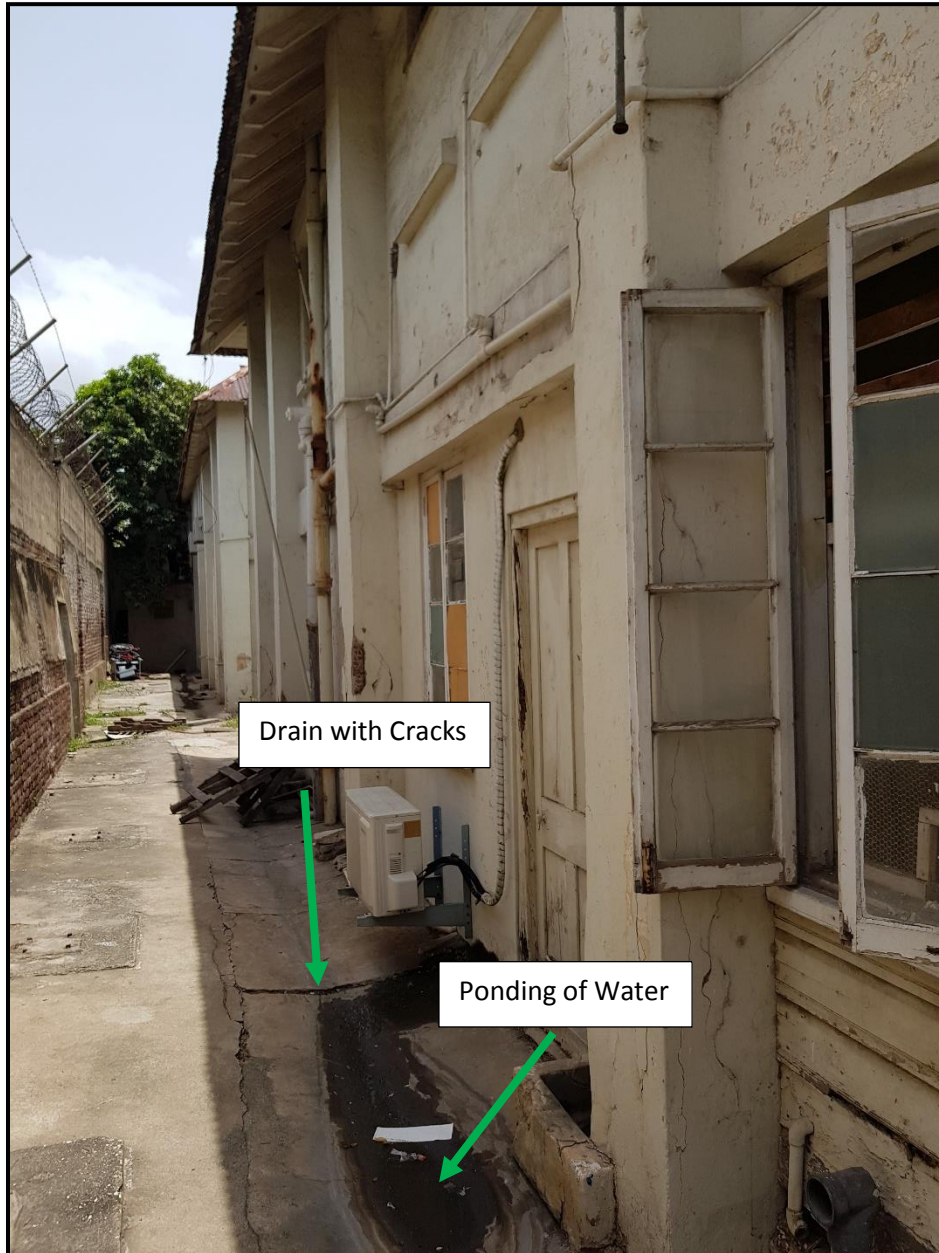
Drainage systems were seen at the site, also rainwater is channelled from the roof which flows in man-made channels. Cracks were seen in the drainage structure which could result in water seeping under the building. All drains should be inspected, clean and repaired if necessary.

Figure 2. Water seeping into the cracks in the drain.

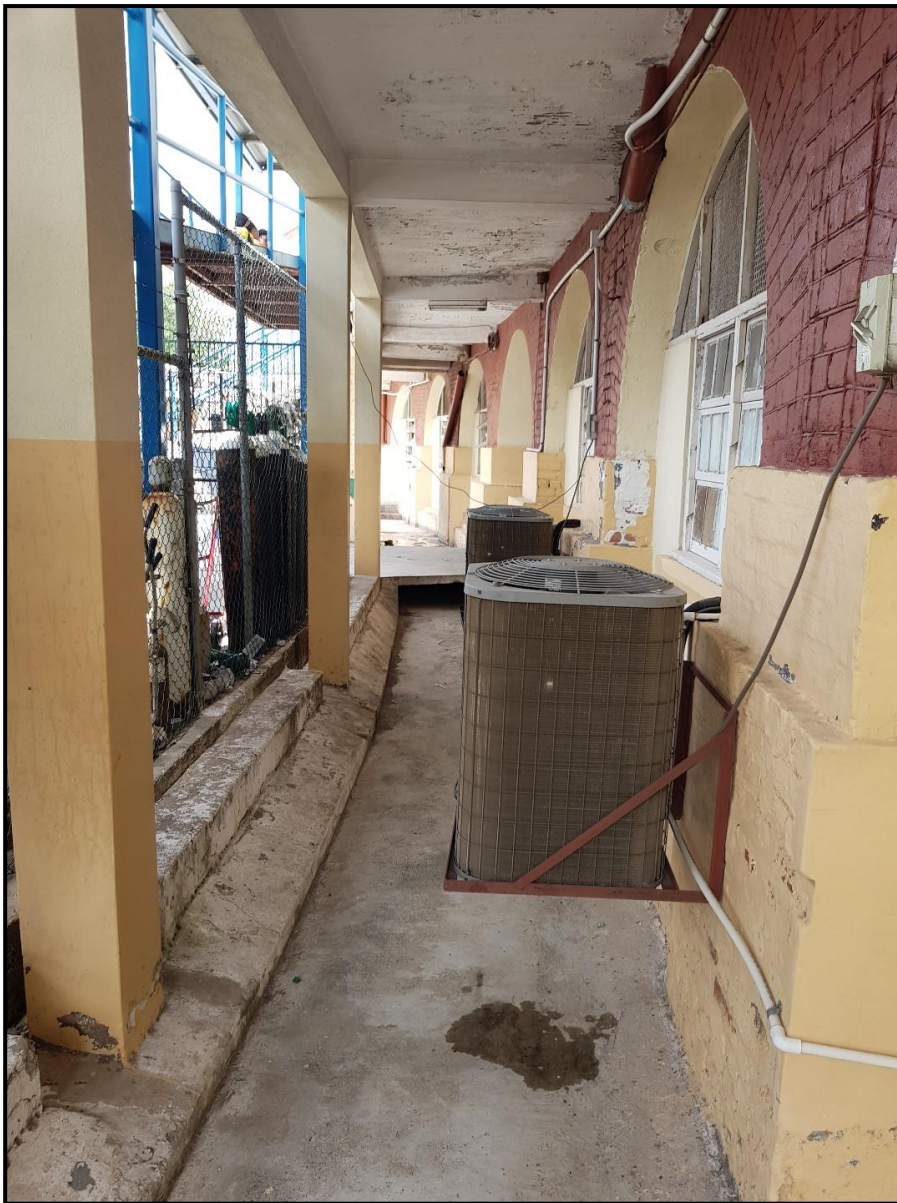
The Mary Seacole Ward has an approximate base area of 5800 square feet. The framework of the building consists of Reinforce Concrete beams, Timber beams and Reinforce Concrete columns in a regular rectangular pattern as shown in the drawing on Page 19. There are noticeable deteriorations which could be a result based on age of the building.

Figure 3. Structural frame of external corridor

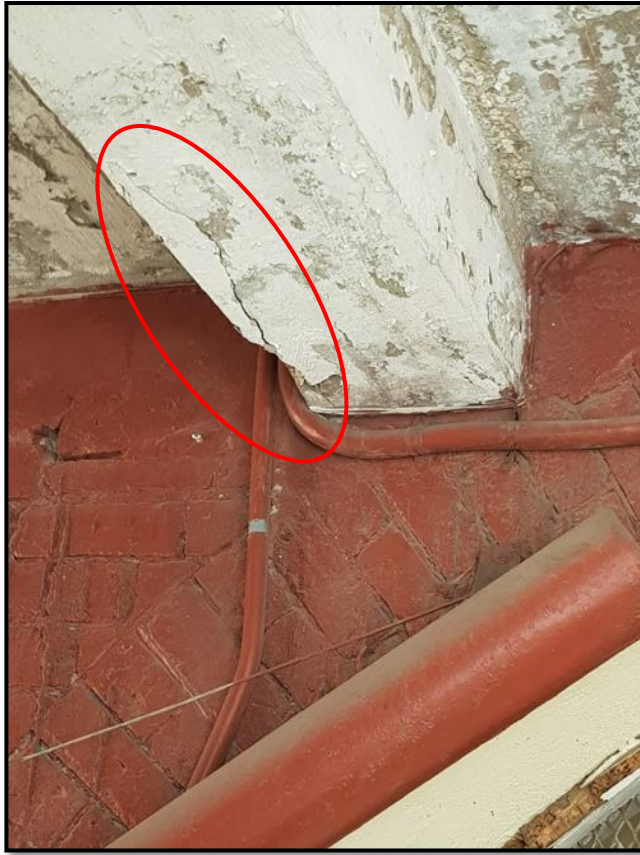
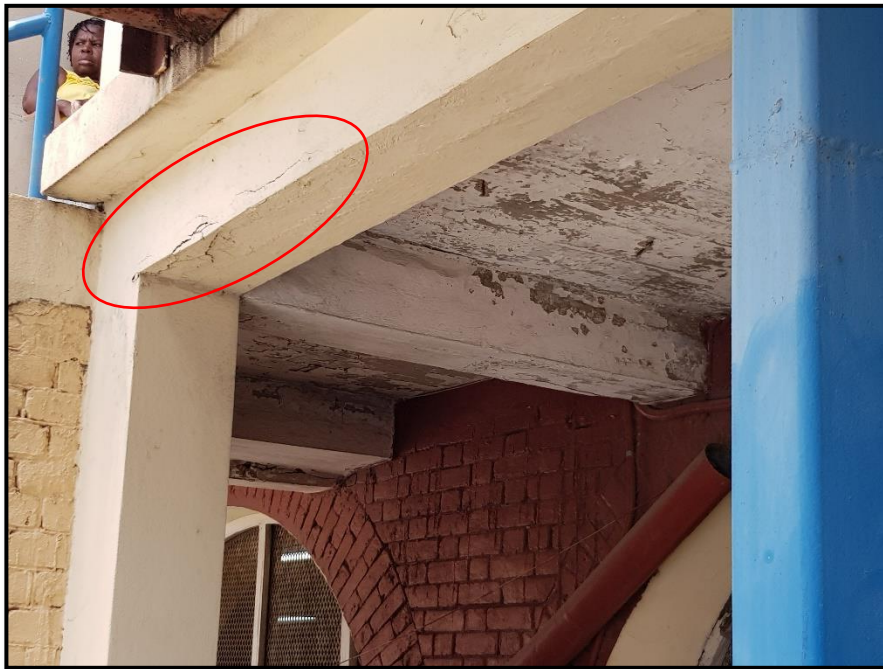
Location: Beam (exterior)

Type of defect: Cracks

Possible reason for failure: Cracks in concrete beams due to corrosion or insufficient concrete cover.

- Remove any loose or unstable concrete.

Clean or smooth cut surface in preparation for:

- Sand blast rebar if exposed.
- Recast with fresh 3000psi concrete.

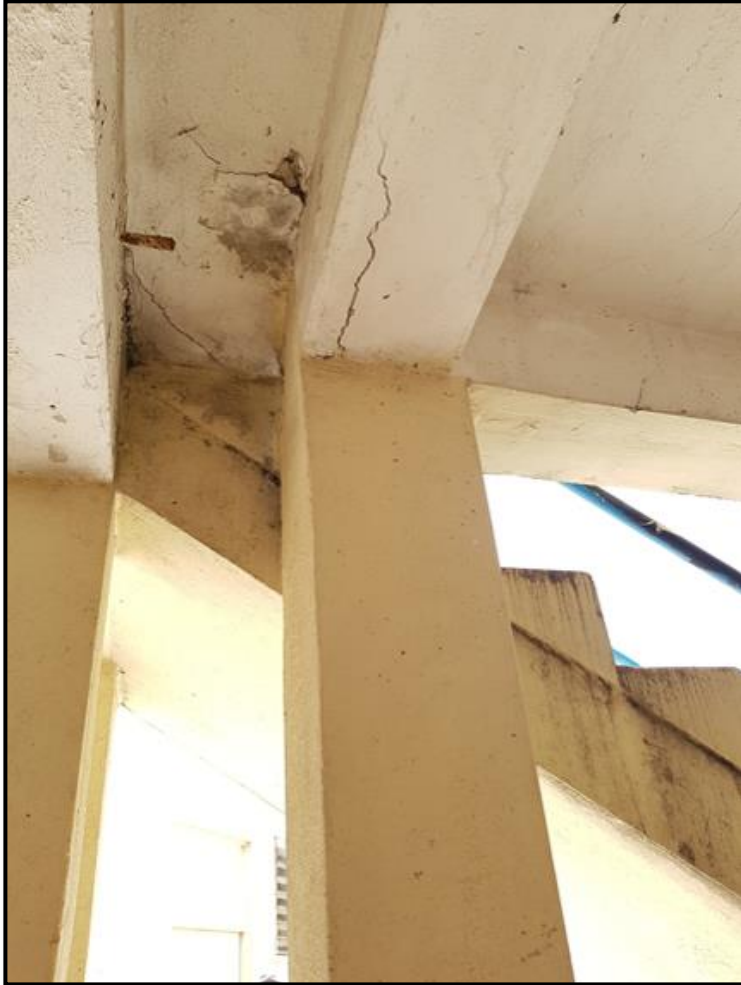
Location: Roof

Type of defect: Leakage (Spalling)

Type of defect: Water Damage and Cracks

Possible reason for failure: Water settles on top of concrete which may have a crack. Then it starts to penetrate and cause the concrete to deteriorate at the bottom.

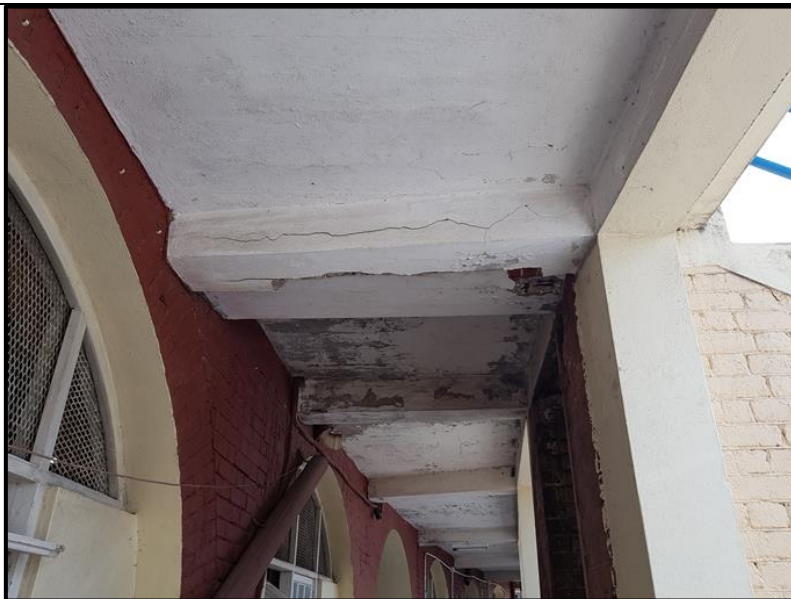
Location: Beam (exterior)

Defect: Cracks

Direction: Horizontal

Reason of Failure: Cracks parallel to main steel are likely due to corrosion in beams.

The cause of this corrosion is also due to provision of insufficient reinforcement cover which leads to corrosion of main reinforcement.

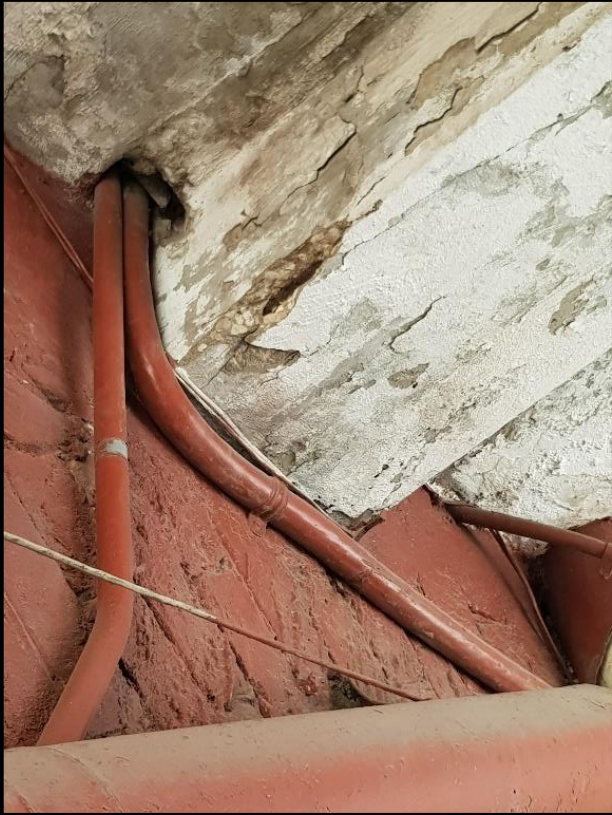
Location: Beam (exterior)  
 Type of defect: Cracks  
 Direction: N/A  
 Possible reason for failure: Insufficient Cover  
 Recommendation:  
 • Remove any loose or unstable concrete.  
 Clean or smooth cut surface in preparation for:  
 • Sand blast rebar if exposed.  
 • Recast with fresh 3000psi concrete.

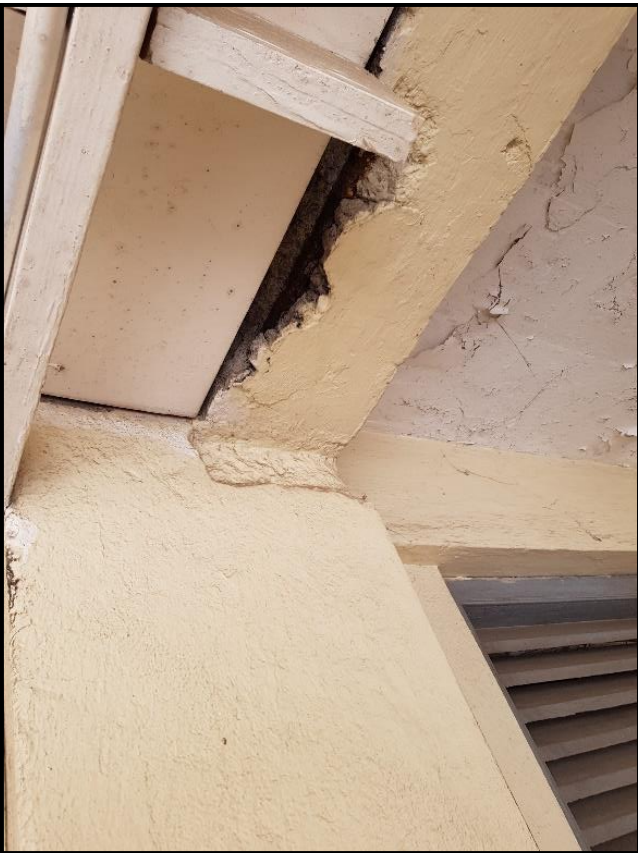
Location: Beam (exterior)  
 Type of defect: Exposed Rebar  
 Direction: N/A  
 Possible reason for failure: Poor construction methods or poor concrete quality.  
 Recommendation:  
 • Remove any loose or unstable concrete.  
 Clean or smooth cut surface in preparation for:  
 • Sand blast rebar if exposed.  
 • Recast with fresh 3000psi concrete.

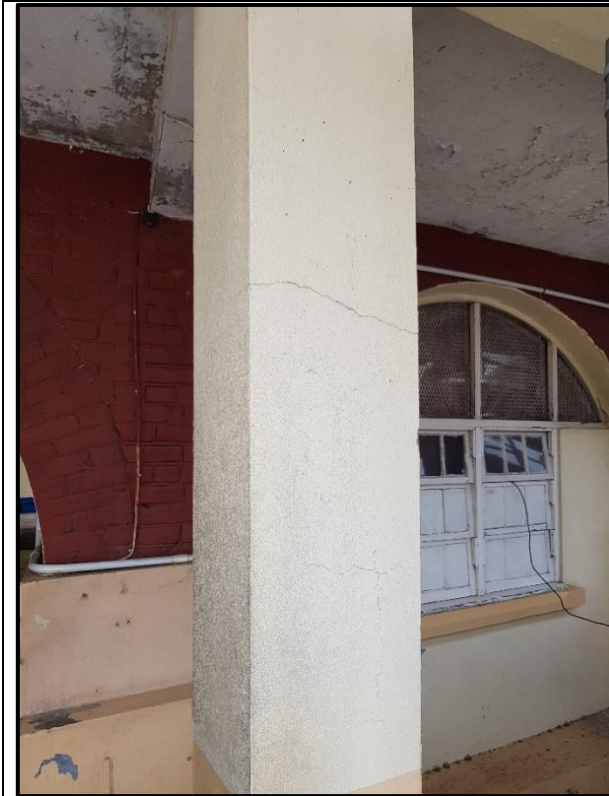
Location: Columns (exterior)  
 Type of defect: Crack  
 Direction: Horizontal  
 Possible reason for failure: This column may have high enough bending to cause tensile forces in the outside face. This condition would produce horizontal cracks which would disappear on the inside face.  
 Recommendation: Observe six (6) month intervals.

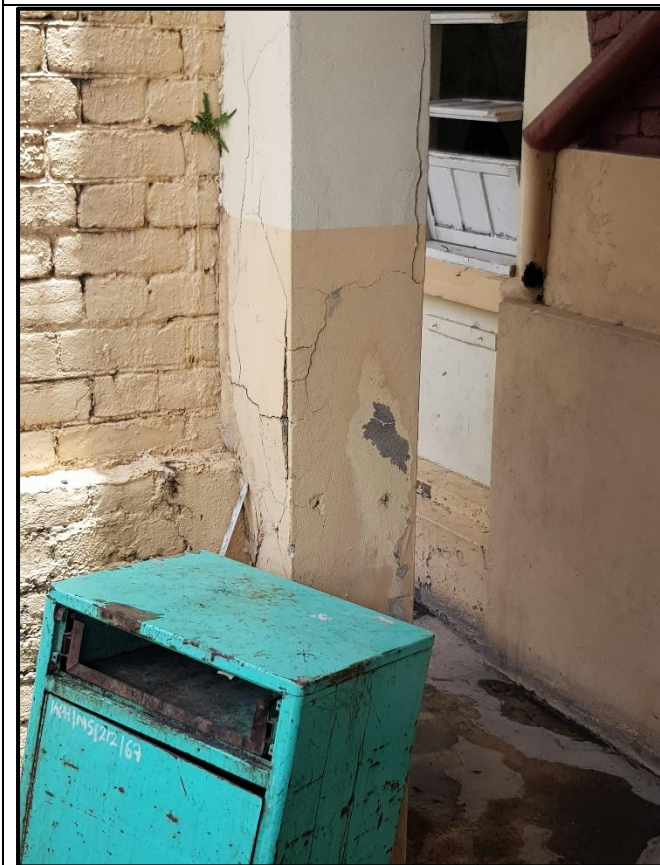
Location: Column (exterior)  
 Type of defect: Spalling  
 Direction: Vertical  
 Possible reason for failure: This is the result of water entering concrete. It forces the surface to peel, pop out, or flake off. It's also known as flaking. This could also be as a result of poor construction.  
 Recommendation:

- Remove any loose or unstable concrete.

Clean or smooth cut surface in preparation for:

- Sand blast rebar if exposed.
- Recast with fresh 3000psi concrete.

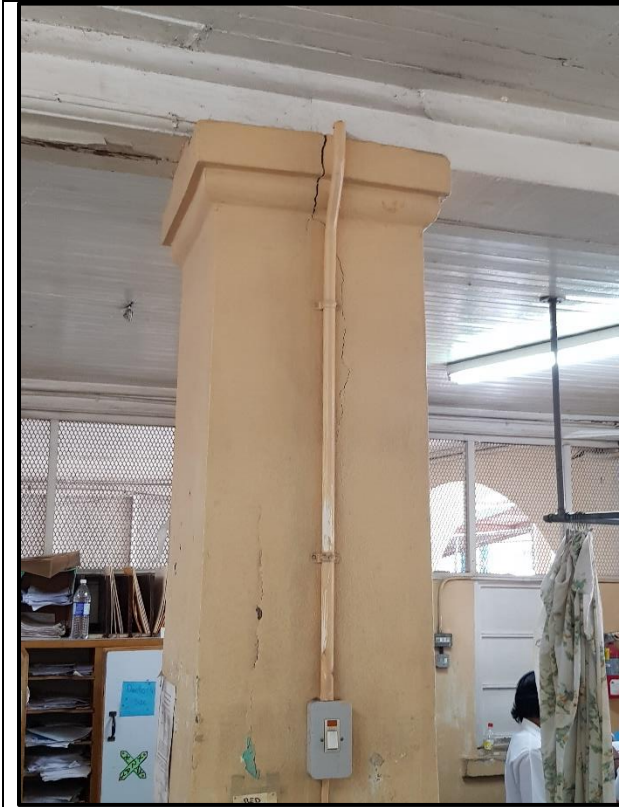
Location: Column (interior)  
Type of defect: Splitting Cracks in Reinforced Concrete Column  
Direction: Vertical  
Recommendation: Observe at six (6) month intervals.

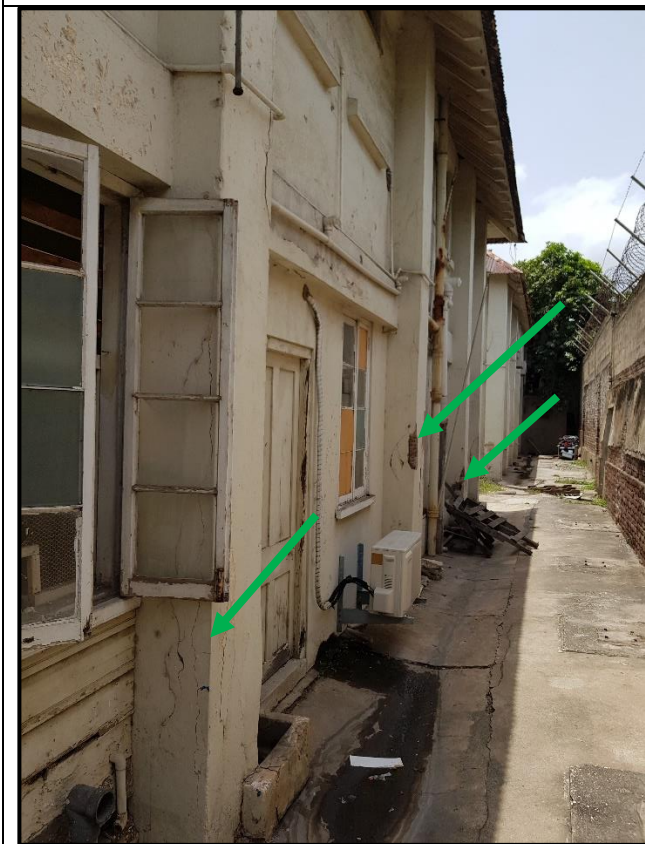
Location: Column (exterior)  
Type of defect: Exposed rebar.  
Direction: Horizontal  
Possible reason for failure: Inadequate cover.  
Recommendation:

- Remove any loose or unstable concrete.

Clean or smooth cut surface in preparation for:

- Sand blast rebar if exposed.
- Recast with fresh 3000psi concrete.

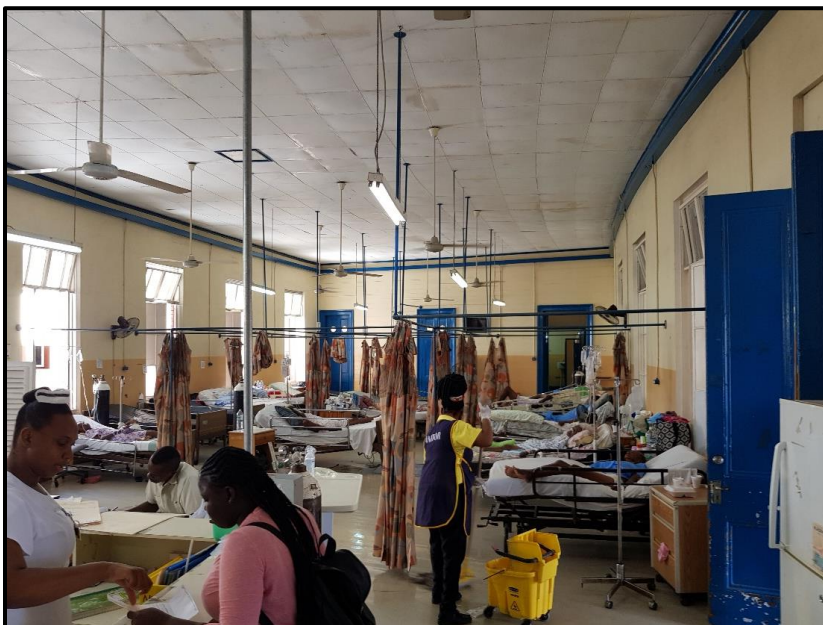
Figure 5. Showing ward adjacent to Marry Seacole.

- The roof is to be refurbished as done on the ward adjacent to Mary Seacole Ward
