# KINGSTON PUBLIC HOSPITAL

Structural Survey on Mary Seacole Ward

02/08/2018

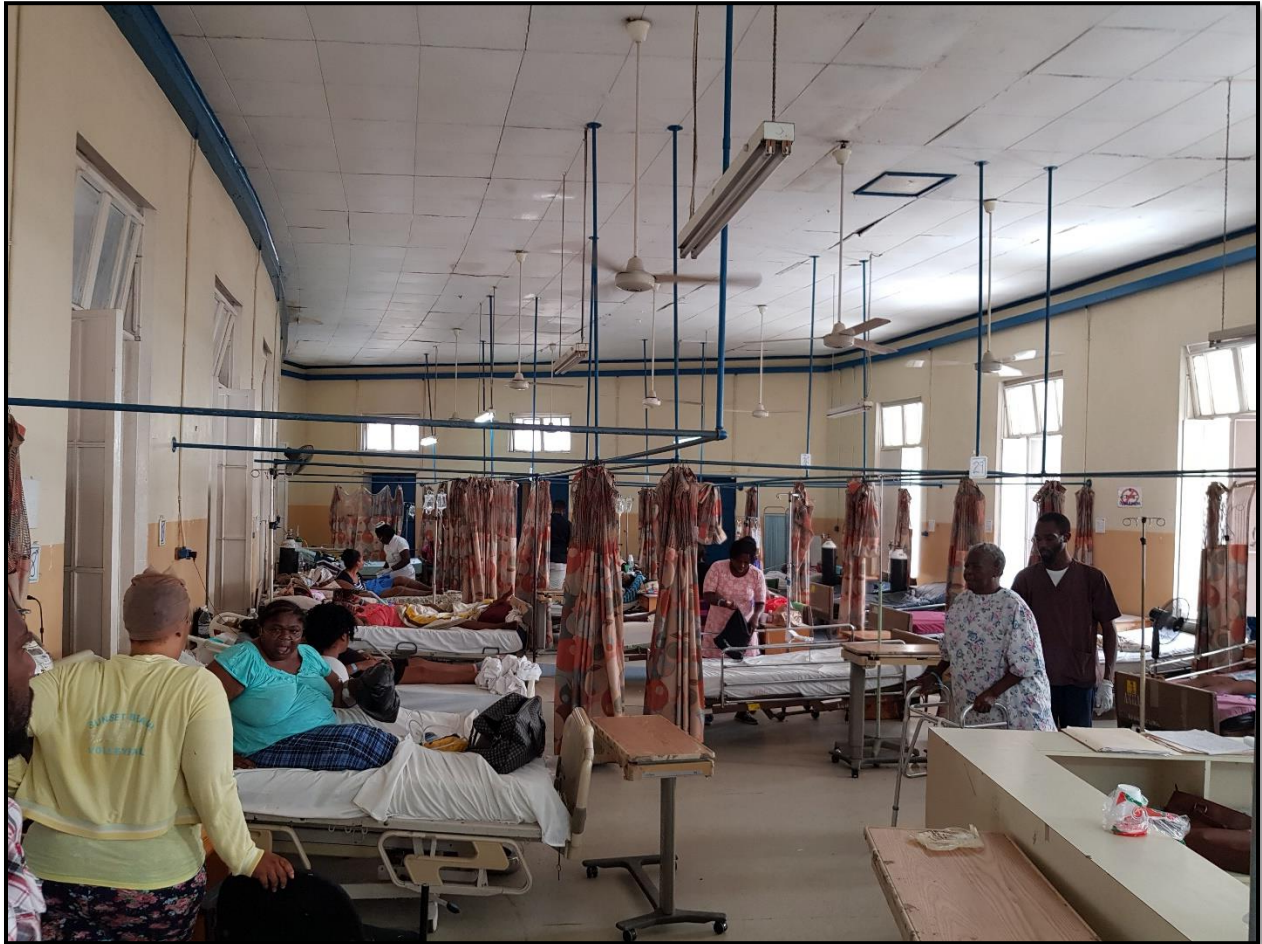
Figure 4. Loading on building structure

The loading on the building includes the dead loads from the roof including ceiling, light, MEP ect. The present live loads are the beds, the furniture and people. The Mary Seacole Ward accommodates up to an average of 40 people in a designated area, this includes patients, visitors, Nurses and Doctors.
